Property Access Checklist

Property ID: 3270	<input type="checkbox"/> WORK STARTED	ON: <u> </u> / <u> </u> / <u> </u>
Property Address: 4710 Elizabeth	<input type="checkbox"/> WORK COMPLETED	ON: <u> </u> / <u> </u> / <u> </u>

**U.S. Environmental Protection Agency
Vasquez Boulevard I/70 Superfund Site
Replacement Certificate**

4710 Elizabeth St.

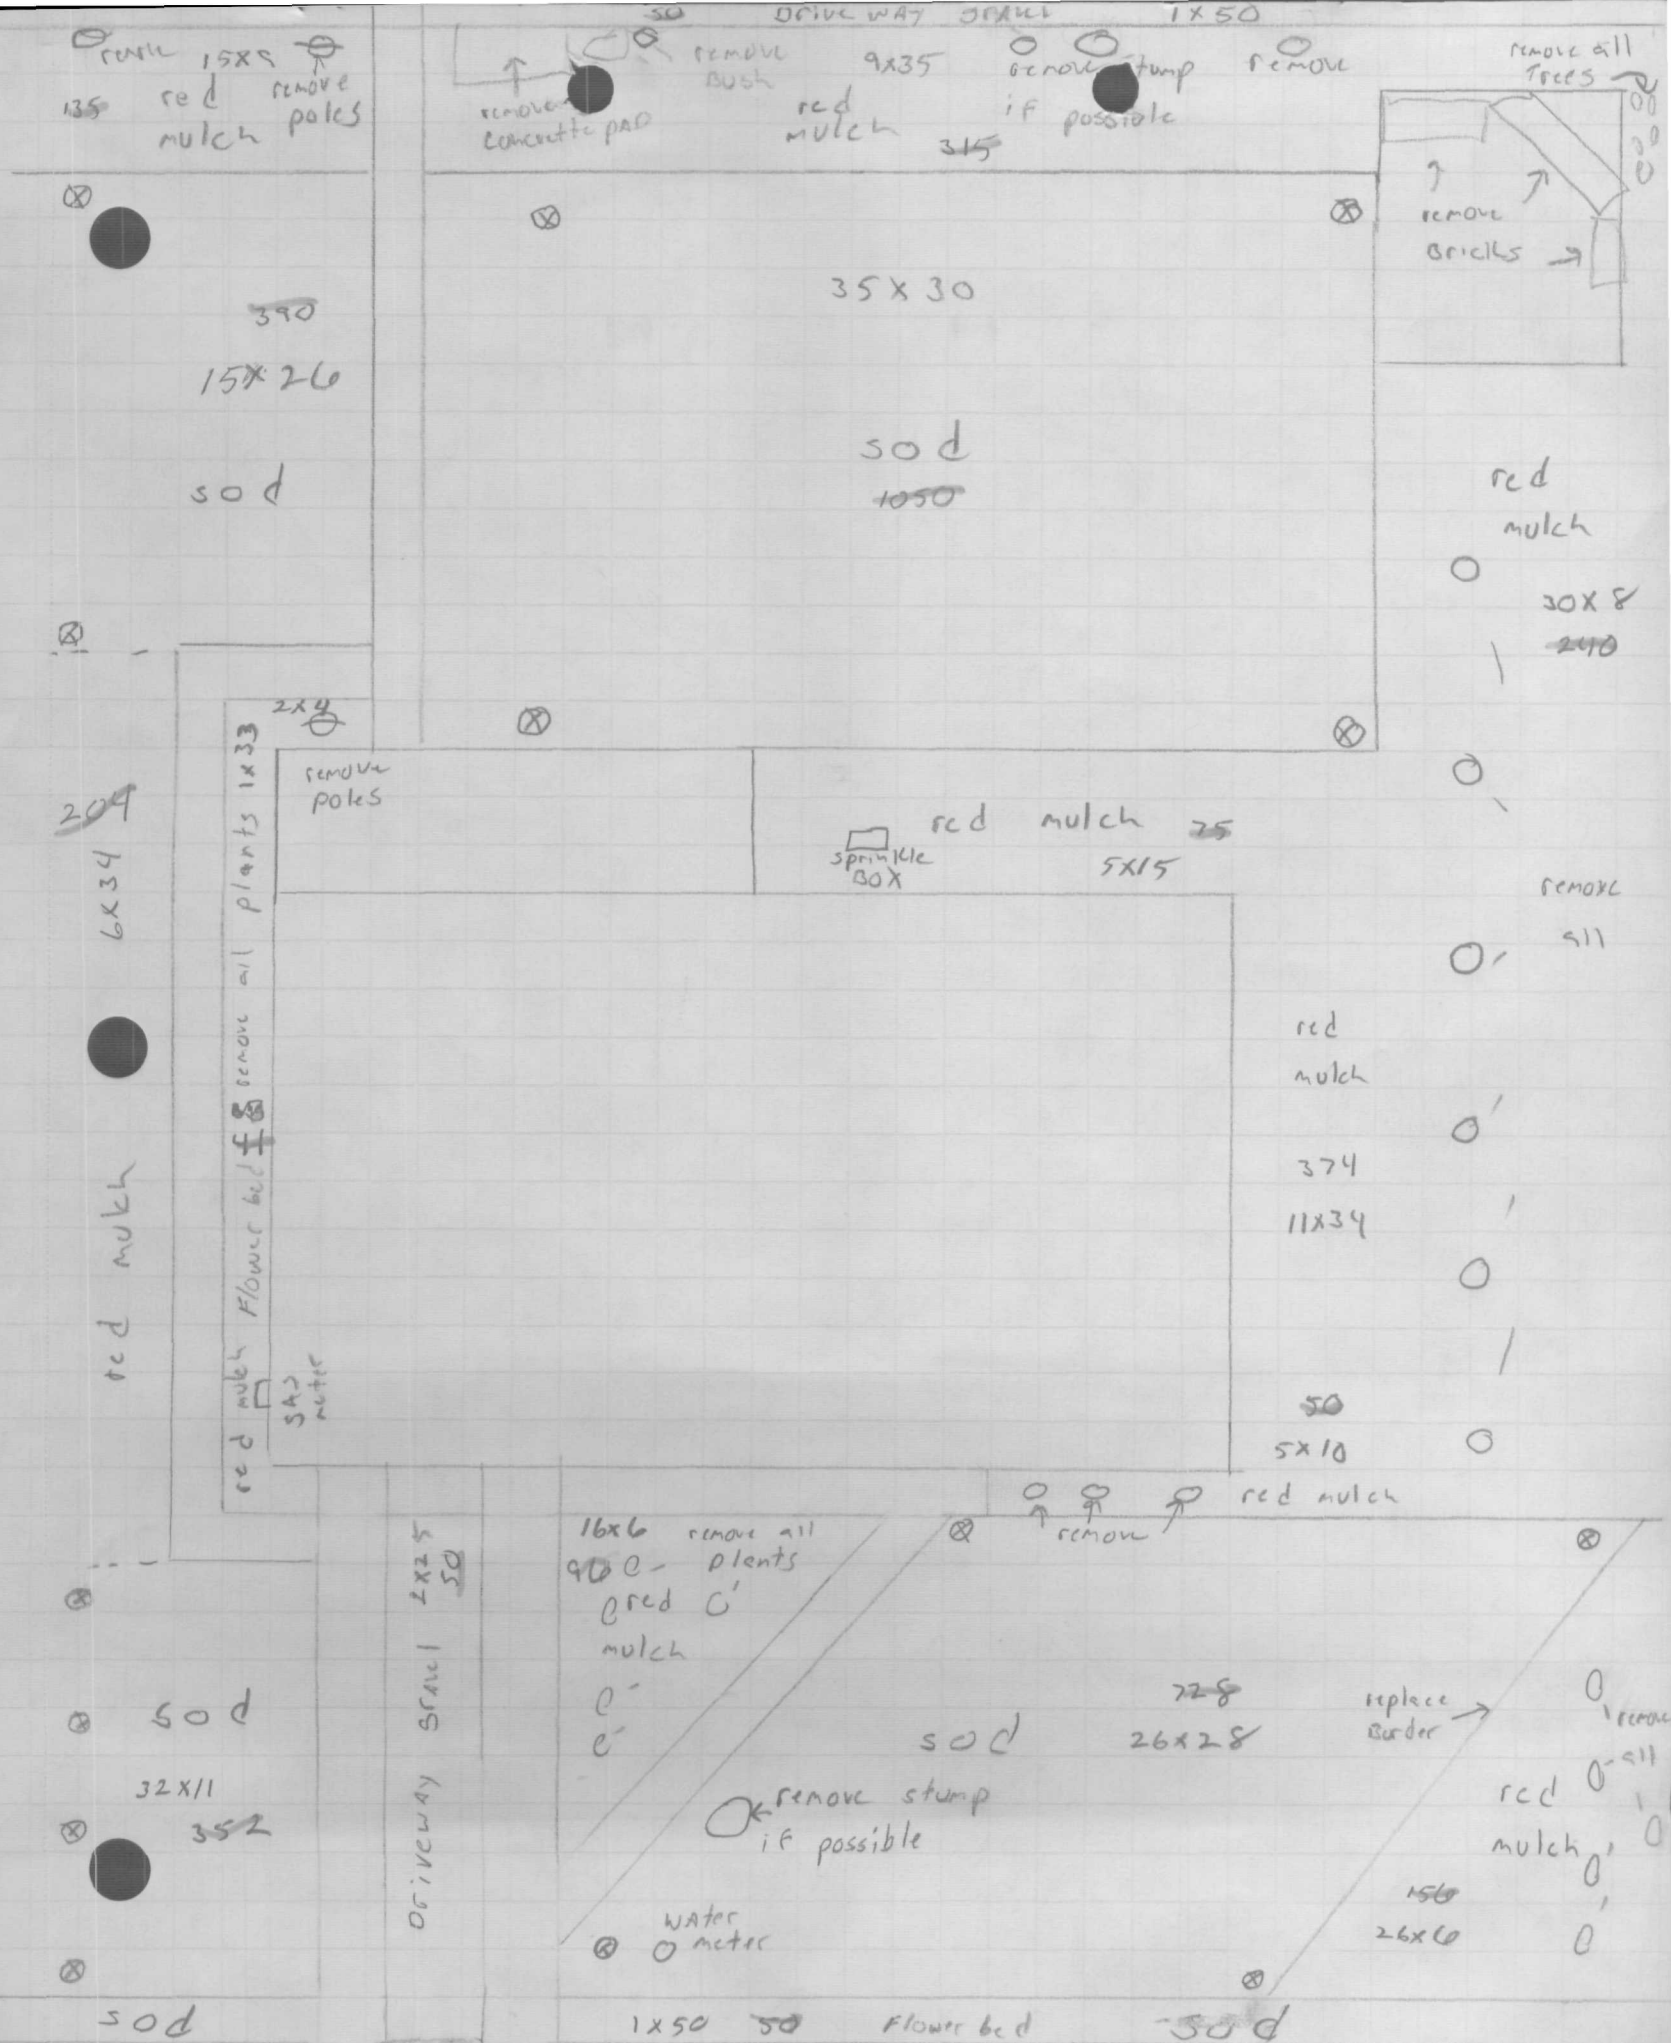
Item:	Backyard sprinkler heads were replaced w/
Item:	wrong heads. they were or should have
Item:	been low gallon. (See Sketch) Need to
Item:	be replaced w/ correct heads.
Item:	
Item:

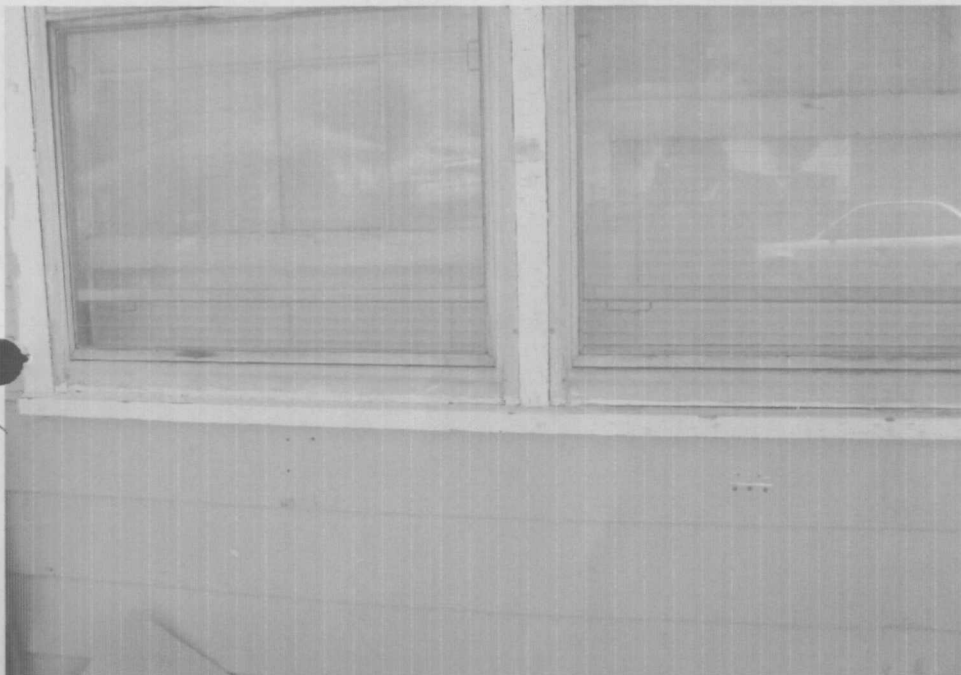
photo 3

Drawing Number	Photo Number	Painted Surface	Material	Color	Total Area of Element (units ft^2)	Percent Deteriorated	Deteriorated Area (units ft^2)	XRF #	XRF Value	pos/neg	Notes
1	1-2	Front Porch Post	Wood	White	19.56	20%	3.91	282	4.9±1.9	POS	
3	1-2	Front Door Threshold	Wood	White	N/A	N/A	0.88	283	0.1±0.2	NEG	
2	3	Front Window Frame	Wood	White	N/A	N/A	1.28	289	4.7±1.6	POS	
N/A	N/A	Wall	Wood	Gray	240.71	20%	48.14	288	4.2±1.6	POS	
					Total Area		53.33				
Address: 4710 Elizabeth St.		Structure: House									
Date: 8/16/05		Direction: N									
Investigator: CM, WH											
Time Started: 11:00 A.M.

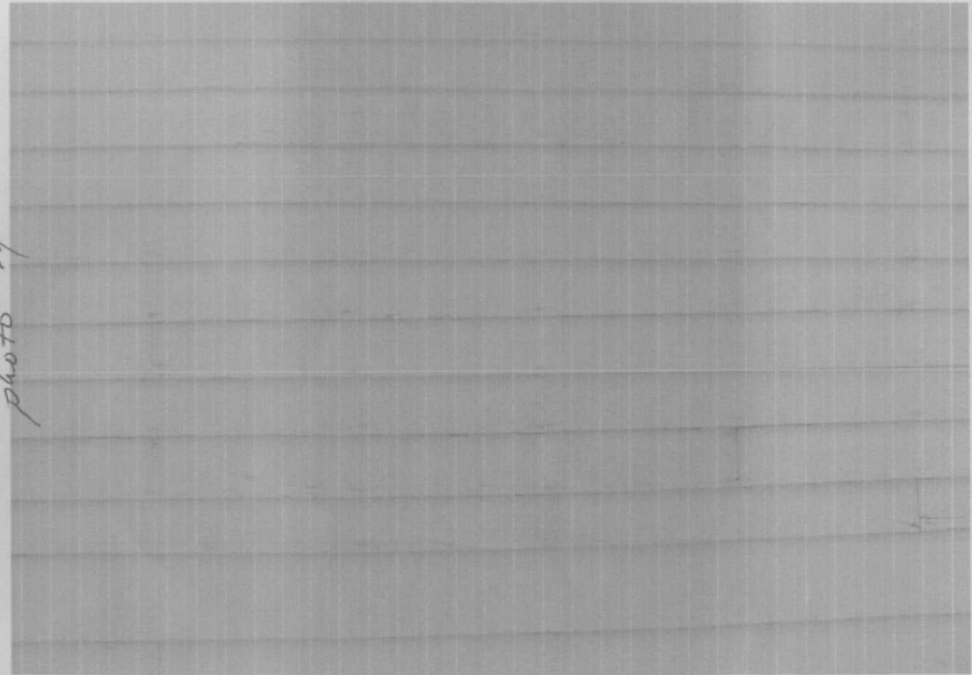
photo 4

Drawing Number	Photo Number	Painted Surface	Material	Color	Total Area of Element (units ft^2)	Percent Deteriorated	Deteriorated Area (units ft^2)	XRF #	XRF Value	pos/neg	Notes
4	4	Wall/Soffit/Rafter Tails	Wood	Tan	258.13	30%	77.44	284	5.12±2.0	POS	
5	5	Window Frame/Screen Frame	Wood	White	N/A	N/A	0.51	285	2.7±2.4	POS	
					Total Area		77.95				
Address: 4710 Elizabeth St.		Structure: House									
Date: 8/16/05		Direction: E									
Investigator: CM, WH											
Time Started: 11:00 A.M.

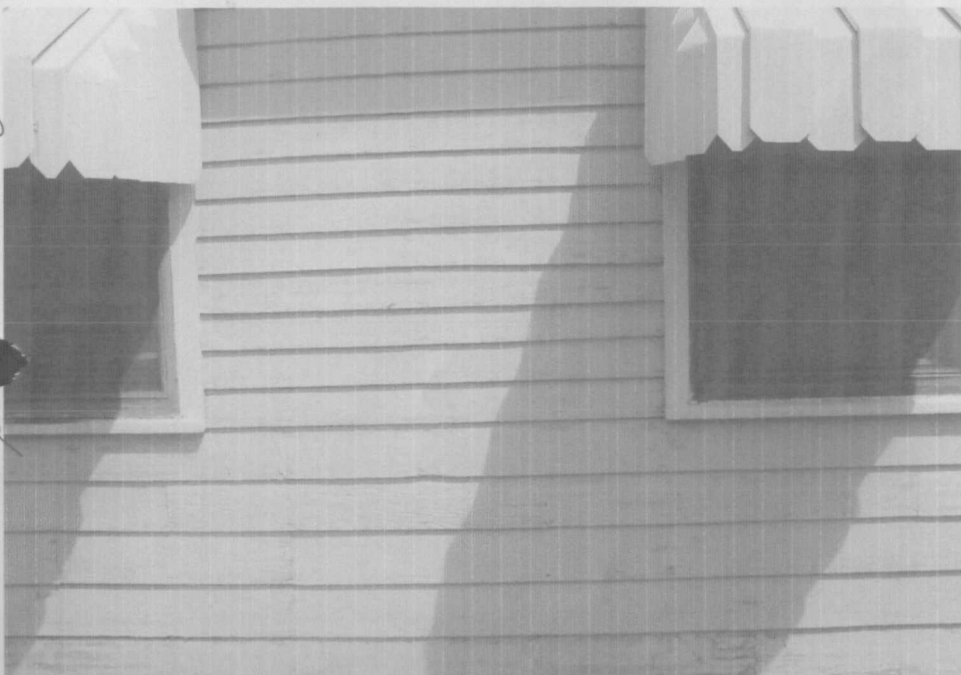
photo 7-8

Drawing Number	Photo Number	Painted Surface	Material	Color	Total Area of Element (units ft^2)	Percent Deteriorated	Deteriorated Area (units ft^2)	XRF #	XRF Value	pos/neg	Notes
8	7-8	Wall/Soffit/Rafter Tails	Wood	Tan	283.53	50%	141.76	See 286	3.9±1.3	POS	
					Total Area		141.76				
					Total for All		644.93

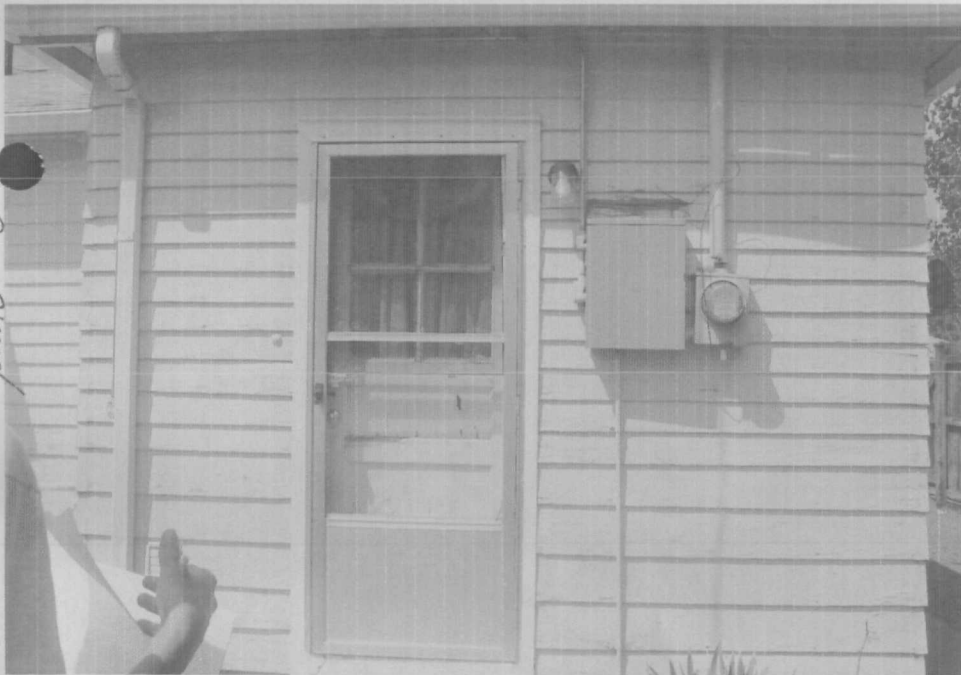
photo 6

Drawing Number	Photo Number	Painted Surface	Material	Color	Total Area of Element (units ft^2)	Percent Deteriorated	Deteriorated Area (units ft^2)	XRF #	XRF Value	pos/neg	Notes
6	6	Wall/Soffit/Rafter Tails	Wood	Tan	370.39	100%	370.39	286	3.9±1.3	POS	
7-Jan	7-8	Window Sill	Wood	White	N/A	N/A	1.5	287	2.8±1.1	POS	
					Total Area		371.89				
Address: 4710 Elizabeth St.		Structure: House									
Date: 8/16/05		Direction: S									
Investigator: CM, WH											
Time Started: 11:00 A.M.
